Executive Summary

The loss of the U.S. flagged cargo vessel EL FARO, along with its 33 member crew, ranks as one of the worst maritime disasters in U.S. history, and resulted in the highest death toll from a U.S. commercial vessel sinking in almost 40 years. At the time of the sinking, EL FARO was on a U.S. domestic voyage with a full load of containers and roll-on roll-off cargo bound from Jacksonville, Florida to San Juan, Puerto Rico. As EL FARO departed port on September 29, 2015, a tropical weather system that had formed east of the Bahamas Islands was rapidly intensifying in strength. The storm system evolved into Hurricane Joaquin and defied weather forecasts and standard Atlantic Basin hurricane tracking by traveling southwest. As various weather updates were received onboard EL FARO, the Master directed the ship southward of the direct course to San Juan, which was the normal route.

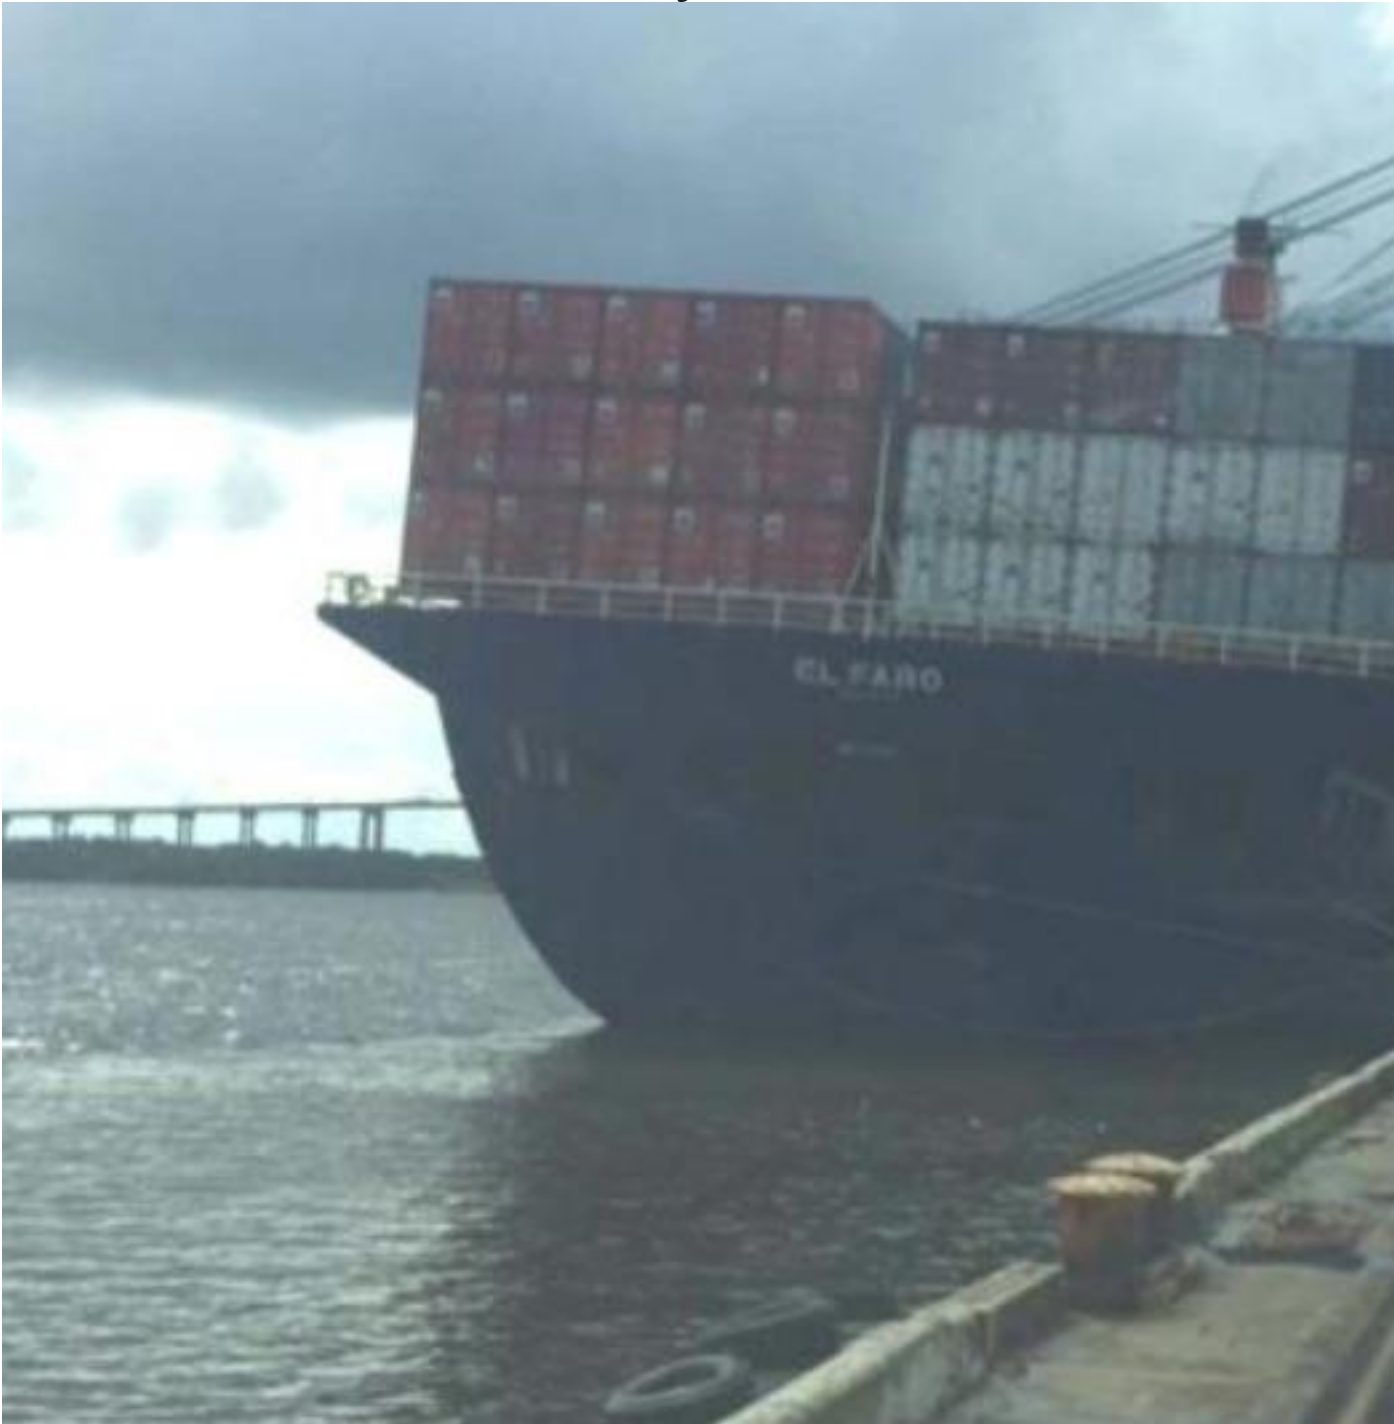
The final photograph taken of the El Faro by TMR Terminal Manager on September 29, 2015, showing starboard list of approximately 4 degrees during loading operations prior to the final voyage. Credit: U.S. Coast Guard

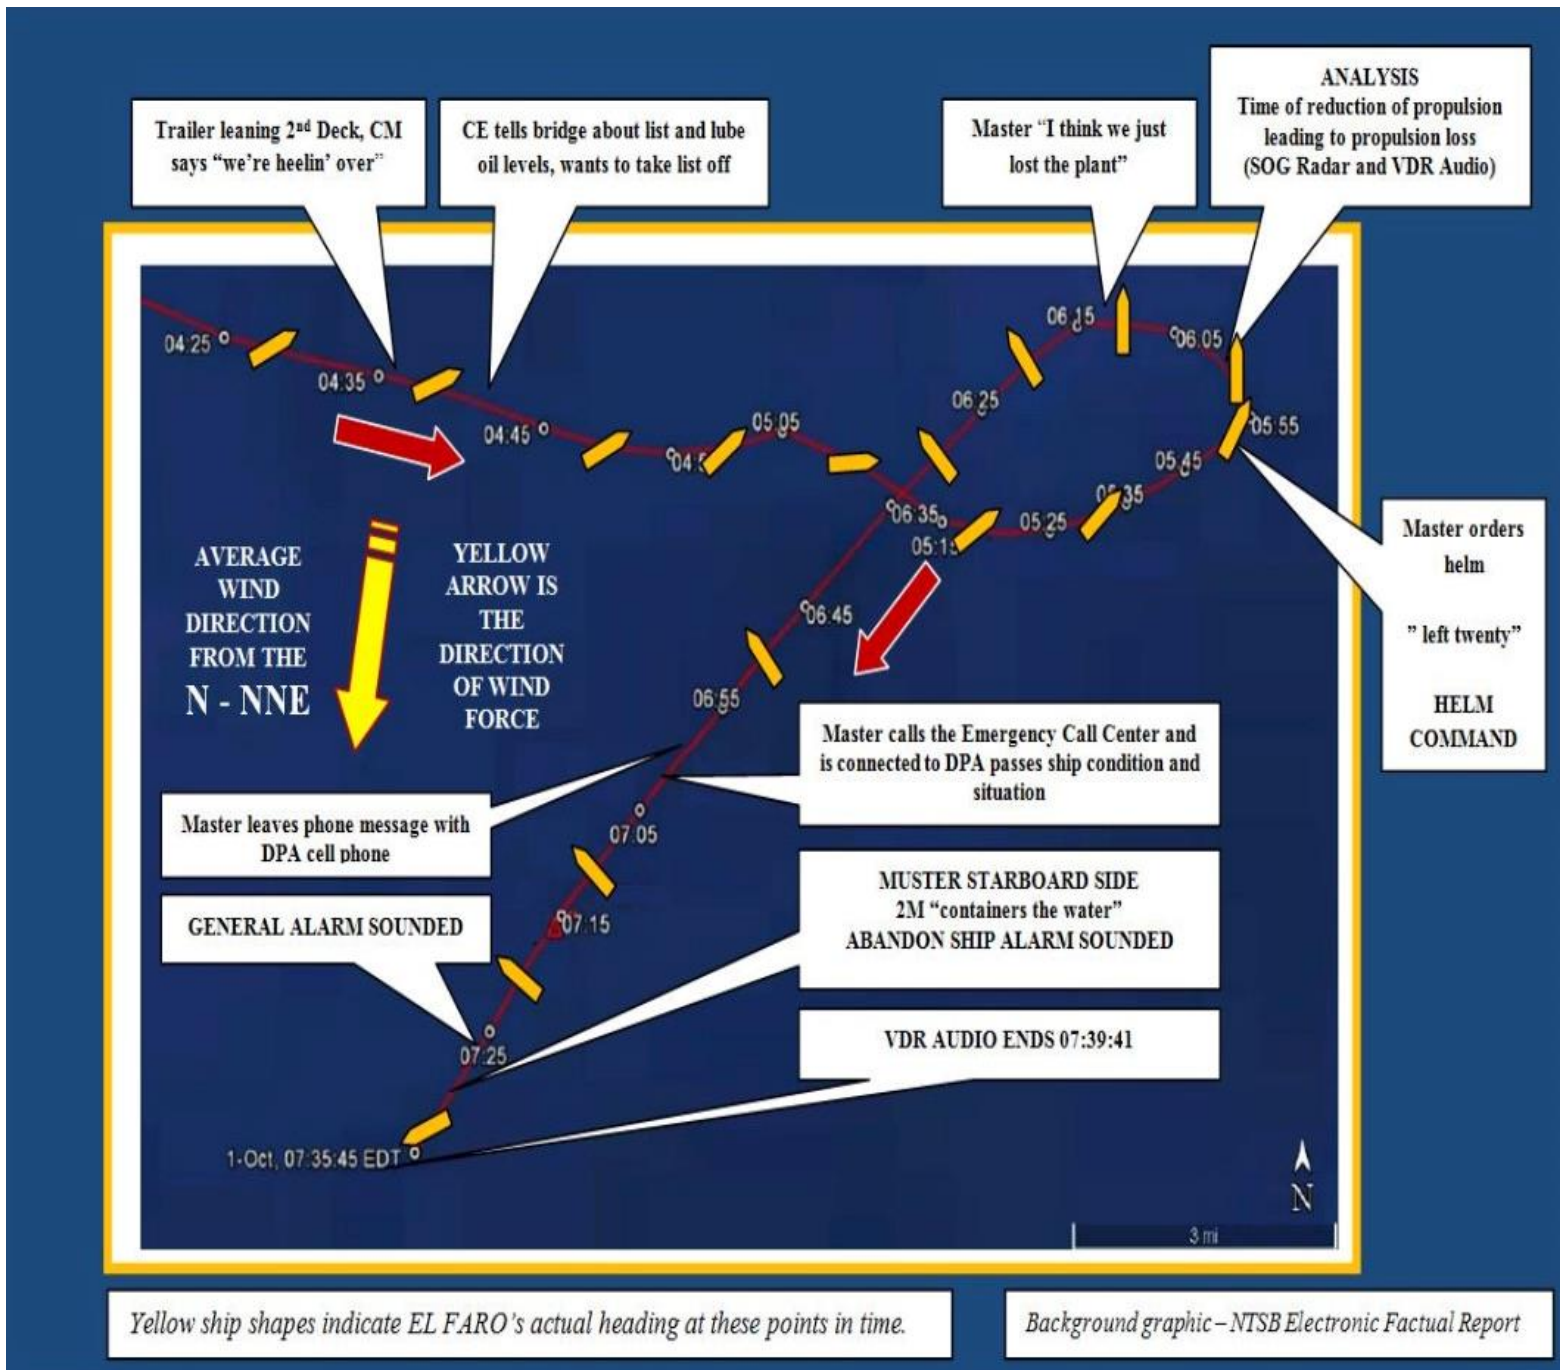
Illustration of significant events between 4:20 AM on October 1 and the sinking, showing ship heading and course over ground. Credit: U.S. Coast Guard
